Unusual Mortality of Pinnipeds in the United Kingdom Associated with Helical (Corkscrew) Injuries of Anthropogenic Origin

Abstract

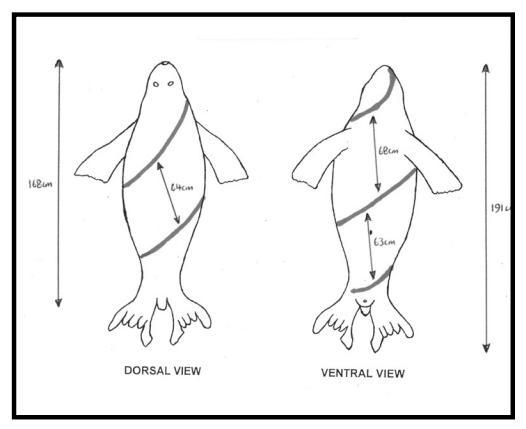
Figure 1. Body diagram showing typical helical wound shape

A corkscrew injury is defined pathologically as a continuous curvilinear laceration that spirals down the body, combined with severe avulsion (degloving) of the skin and blubber from the underlying fascia. Despite occurring in many different geographical areas, both in the UK and Canada, the corkscrew lesions are remarkably consistent in all cases, suggesting a common mechanism is responsible. Degloving injuries are generally

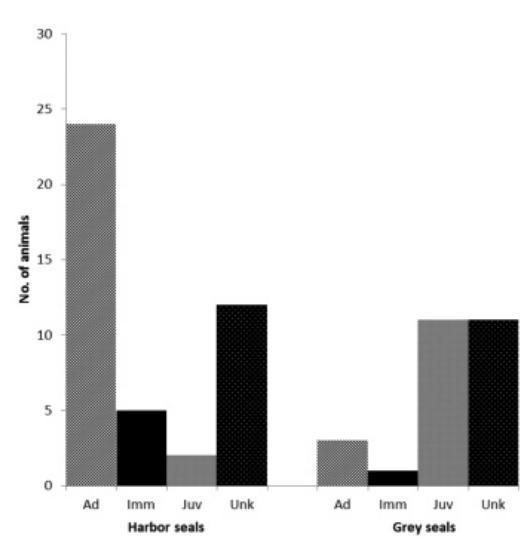
Figure 2a. Age structure of pinnipeds with corkscrew injuries in United Kingdom (2008-2010)

female (89%), and of these, 21 were adults (84%) (Figure 2a). Thirty-two harbor seals (86%) were found in the summer months of June, July, and August (Figure 2b). Of the grey seals for which age-class was determined, 11 were juveniles (73%) (Figure 2a); there was also a seasonal peak for this species with 12 of the total number (67%) found in December (Figure 2b). Pinnipeds with characteristic lesions were recorded in England, Scotland, and Northern Ireland, with apparent hotspots in Norfolk, England (42) and Fife, Scotland (16), which together accounted for 76% of the recorded UK cases.

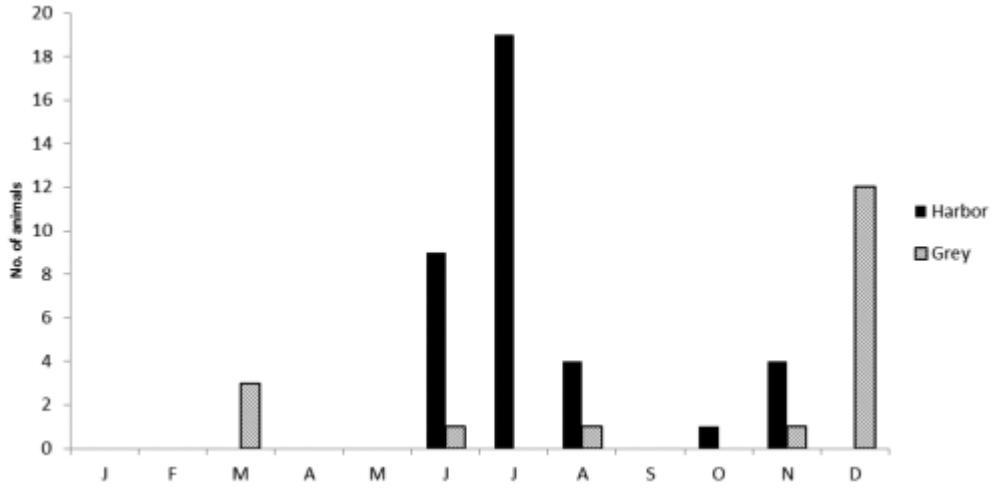
Figure 2b. Month of stranding of pinnipeds with corkscrew injuries in UK (2008-2010)

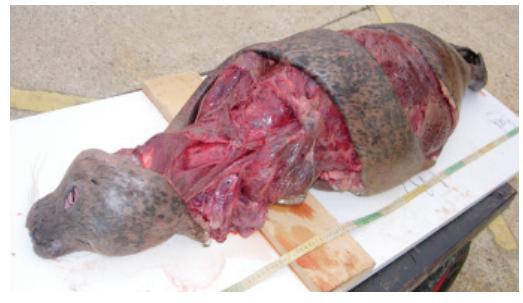
Figure 3. Typical gross appearance of corkscrew injuries

Necropsy finding	Number $(N = 20)$
1. Continuous helical skin laceration originating at the head and spiralling down the body terminating between the ribcage and pelvic area (<i>corkscrew wound</i>) (Figure 3)	20 (100%)

2. Skin and blubber sheared from the underlying fascia with connective tissue attachments torn caudolaterally (Figure 3)	20 (100%)
3. Scapular attachments to the axial skeleton severed and the fore flipper partially degloved	18 (90%)

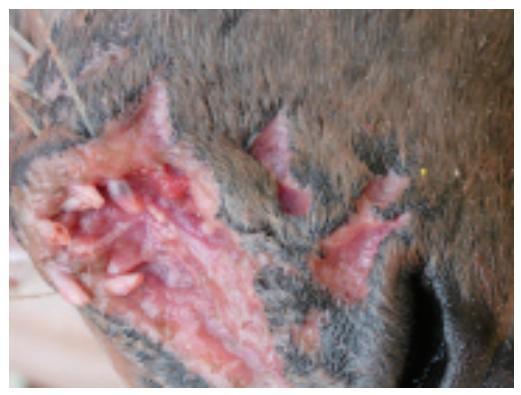
Figure 4. Regularly spaced triangular claw-like lesions lateral to right nostril

13. Patterned injuries comprising a series of linear or triangular wounds or abrasions 15 mm in length and 12 to 15 mm apart (see Figure 4)	5 (25%)

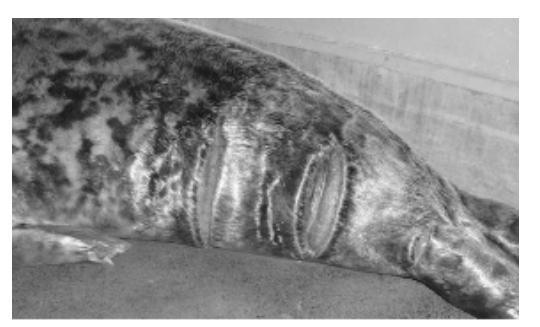
Figure 5a. Parallel chop wounds from propeller strike

The injuries bore little resemblance to previously recognised causes of trauma in pinnipeds: a boat propeller strike typically produces a series of deep, parallel, regularly spaced lacerations, usually to the flank or dorsum (Goldstein et al., 1999; Gulland et al., 2001; Wood, 2001; Lightsey et al., 2006); entanglement in discarded rope, netting, and other man-made debris usually results in the material becoming wrapped around the neck causing deep circumferential wounds (Stroud & Roffe, 1979; Bonner & McCann, 1982; Fowler, 1987; Stewart & Yochem, 1987; Goldstein et al., 1999); and shark attack generally results in a characteristic U-shaped bite mark with a serrated edge and tooth marks, although, to the authors' knowledge, shark predation has never been confirmed in the UK (Brodie & Beck, 1983; Alcorn & Kam, 1986; Lucas & Stobo, 2000; Gulland et al., 2001) (see Figures 5a, 5b & 5c). Pinnipeds can also be injured during intraspecific fighting, by dog attacks, and by falling on rocks and other natural features, resulting in puncture wounds and abrasions, mostly to the flippers and ventrum (Stroud & Roffe, 1979).

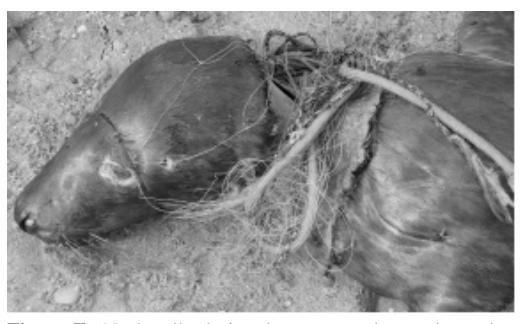
Figure 5b. Neck collar lesion due to entanglement in marine debris

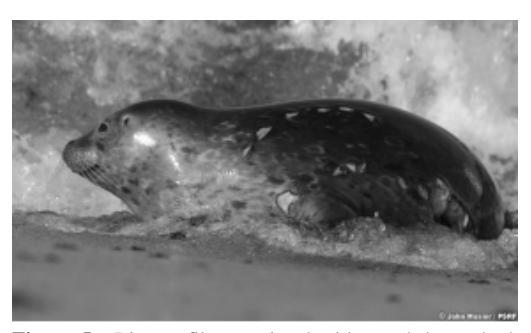
Figure 5c. Bite profile associated with attack by a shark (Courtesy of John Mosier, Pelagic Shark Research Foundation)

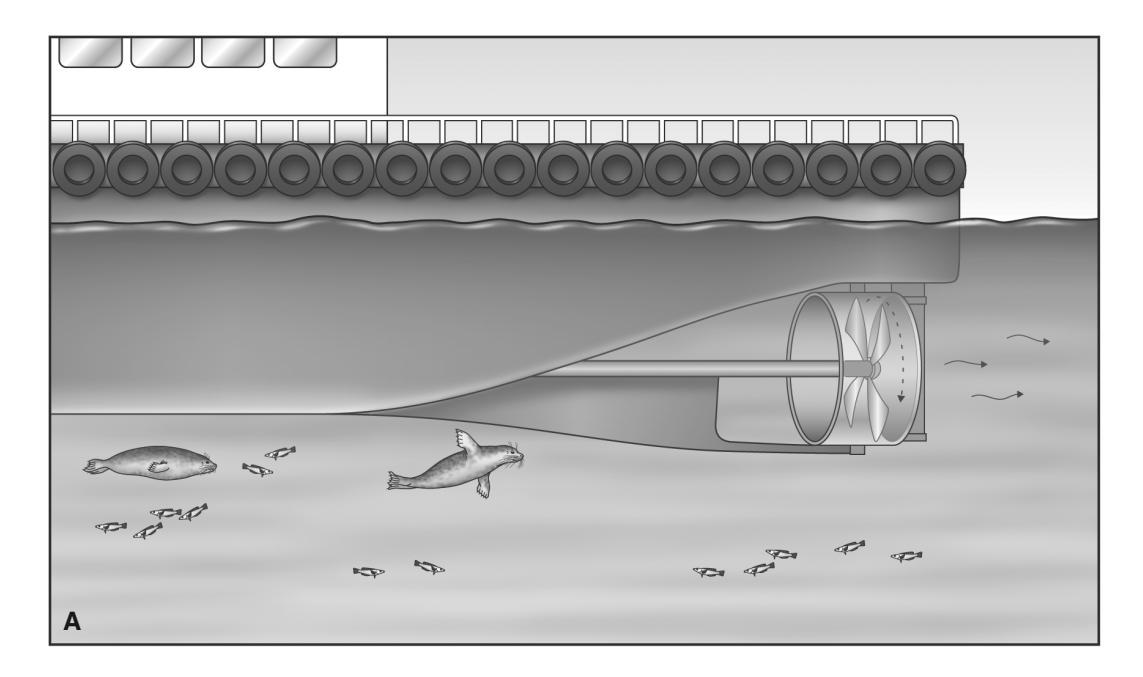
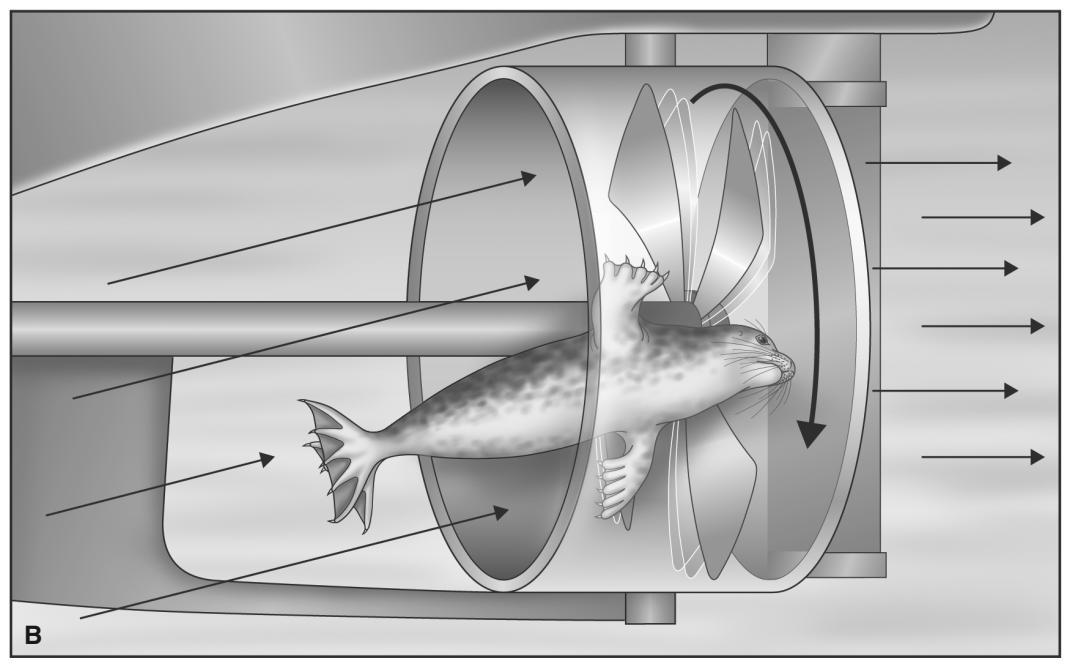
Figure 6. Seal injuries in propellers (Author: Steve Bexton BVMS MRCVS; Artist: Debbie Maizels [debbie@zoobotanica.com])

No significant mechanical devices were identified in the local areas other than maritime vessels, and these were generally comprised of regular fishing boats, small commercial vessels, and some recreational boats. Most of these vessels have conventional screw propellers that would not cause corkscrew lesions if a seal was struck, but would instead result in pathognomic parallel chop wounds (Figure 5a) (Goldstein et al., 1999; Gulland et al., 2001; Wood, 2001; Lightsey et al., 2006). However, workboats, including tugs, multipurpose work vessels, and offshore support vessels were also occasionally operating in all of the locations, and, in some areas, particularly in Norfolk, there appeared to be a correlation between such vessels and the seal injuries. These vessels are often equipped with propellers housed within cylindrical nozzles or other thrust-augmenting devices (e.g., kort nozzles or azimuth thrusters) to improve efficiency and manoeuvrability, especially at high thrust and low speeds (Gaston, 2002; Carlton, 2007). These devices possess the components needed to create the corkscrew injuriesnamely, rotating blades and powerful mechanical shearing forces-and also generate a strong suction effect that is known to pull objects through (Carlton, 2007). A marine mammal encountering a ducted propeller would not sustain chop wounds because the tip of the blade is shielded by the nozzle and the clearance between the outer edge of the blade and the inner surface of the nozzle is very small (Carlton, 2007). However, if the propeller duct was of sufficient diameter to accommodate the body of a seal, the seal could be drawn through the device while suspended in the stream of fast moving water. Because of its hydrodynamic body contour, the seal could pass between the rotating blades, encountering the leading blade edge, thus resulting in a helical laceration down the body (Figure 6b). The strong shearing force would cause avulsion of the skin and blubber, but significant lateral crushing injuries would be avoided because the force was primarily directed

tangentially. The only appendages projecting from the pinniped body are the fore flippers, and, in many cases, these had been torn from the body at the scapular joint consistent with this mechanism. The skull injuries seen in some seals may be the result of the initial impact with the rotating blade as the animal enters head first. Further evidence may be provided by the patterned injuries present on some bodies which consisted of regularly spaced identical lacerations (Figure 4) or imprint abrasions that could correspond to an initial encounter with a structure forward of the nozzle such as a rudder or rope cutter.

The pathological findings in the 20 harbor seals examined in this study are consistent with the animals having been pulled through ducted propellers. In some cases, there was an apparent correlation between the appearance of carcasses on shore and the presence of work boats operating in the vicinity, although a direct causal link was difficult to establish because of a lack of witnesses and the indeterminable time between seal death and stranding. The first reports of corkscrew injuries came from Sable Island in the early 1990s, which coincided with the installation of offshore oil and gas projects on the Scotian shelf close to the island. The first recorded cases in the UK appear to coincide with the recent expansion of the offshore renewable energy industry and the associated increase in work boat activity in littoral waters. Further research, including laboratory scale experiments, is necessary to confirm the exact causal mechanism involved. It is also important to identify the precise vessel characteristics and operational conditions that result in these seal deaths, including why the seals are apparently being drawn to these devices, in order to understand the problem and develop long-term mitigation measures. Assuming many carcasses do not make it ashore, the potential impact of this phenomenon could be much greater and could even be having negative effects at a population level.
